Aerosol Sealing of Existing Homes from Attics and Crawlspace

Final Report

ET22SWE0037

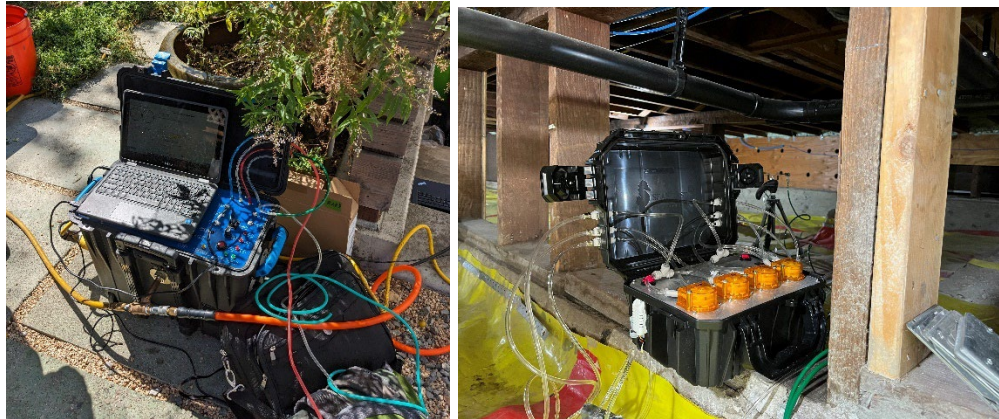
Figure 1. Aerosol sealing control unit (left) and remote injector unit (right).

Prototype equipment was provided by the manufacturer with input from the research team. The sealing kit includes one control unit and four remote units each with two sealant pumps (Figure 1). Compressed air is routed through the control unit, which monitors pressure, and out to the remote

units in the attic or crawlspace. Sealant is held in portable two-gallon containers near the remote units, which pump the liquid to the nozzle while monitoring relative humidity. The pumps will automatically shut off if the humidity exceeds 90 percent, and will restart once the humidity conditions drop. The manufacturer provides a 10-year warranty for the product and it is assumed that this warranty would also apply to the new application for existing residences.

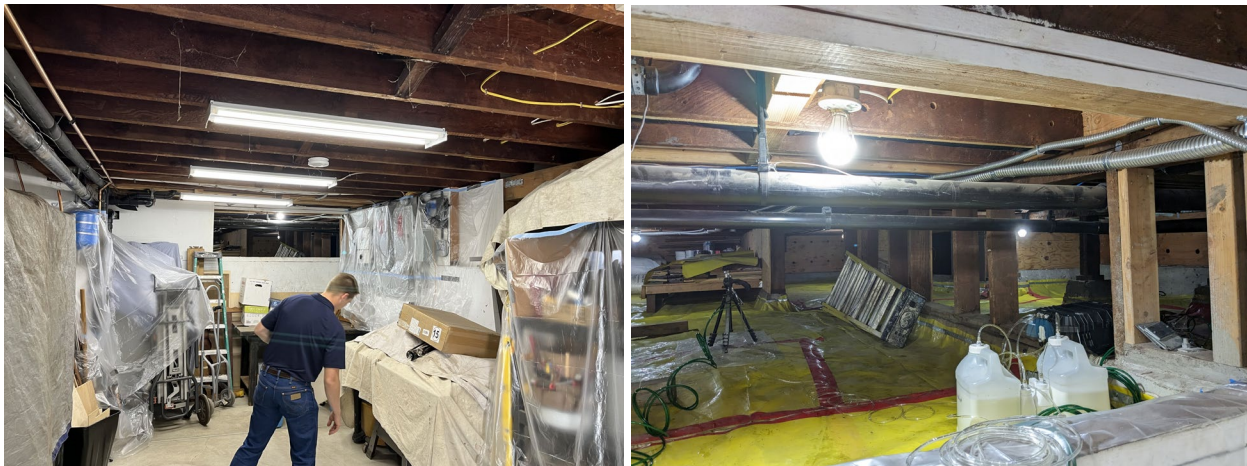
Figure 2. Basement/crawlspace area of Site 1.

The first site recruited was a single-family 1,420 ft² home in California climate zone 3. It was originally built in the early 1900s but underwent a gut rehabilitation project within the last 10 years. The home was a single story with a conditioned attic, which prevented the sealing technique from being used in that space. The attic was sealed and insulated below the roof deck, essentially making it part of the conditioned envelope. There was an unfinished basement under part of the house and a crawlspace in the remaining portion. Minor preparatory work was required, including covering a whole house battery and other items stored in the basement (Figure 2). Four nozzles were placed centrally in the crawlspace, pointed outward to provide maximum coverage of the area. This site was chosen because of the easy basement access and the eagerness of the homeowner to participate.

Site 1 had a small basement connected to the crawlspace area and included an exterior door that allowed the research team to perform guarded testing. With the basement depressurized to -50 Pa, the house reached -10 Pa relative to outside, which provided a qualitative assessment of the extent to which the house and basement were connected through air leakage. A guarded test showed that there was a total of 283 CFM50 of envelope leakage through the floor between the house to the basement. A post-seal test showed that the aerosols successfully sealed 87 percent of this floor leakage, and another guarded test showed no measurable pressurization of the occupied space when pressurizing the basement, demonstrating that very little leakage connection remained between the zones. Total sealing time was about one hour, with about 1.5 hours of setup, including covering of contents in the basement and cleanup. The overall envelope leakage sealed was 247 CFM50 (1.14 ACH50) for a final result of 400 CFM50 (1.9 ACH50).

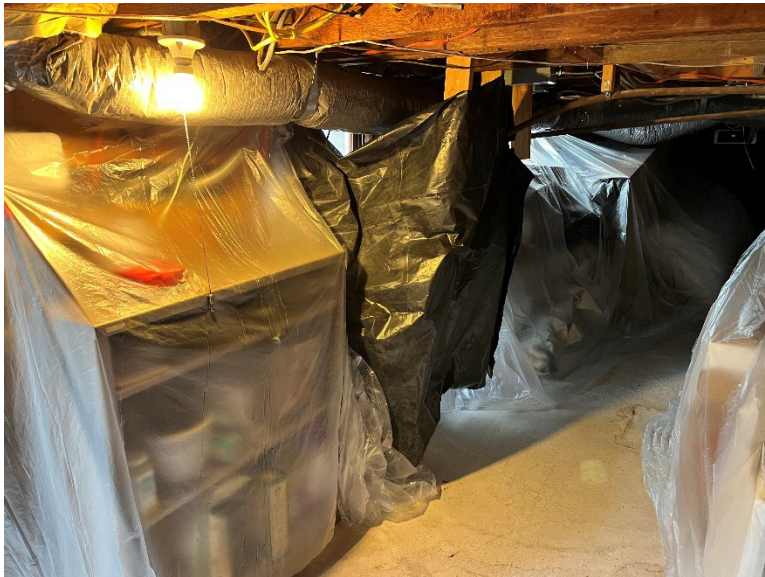
Figure 4. Example of plastic used to protect a storage area.

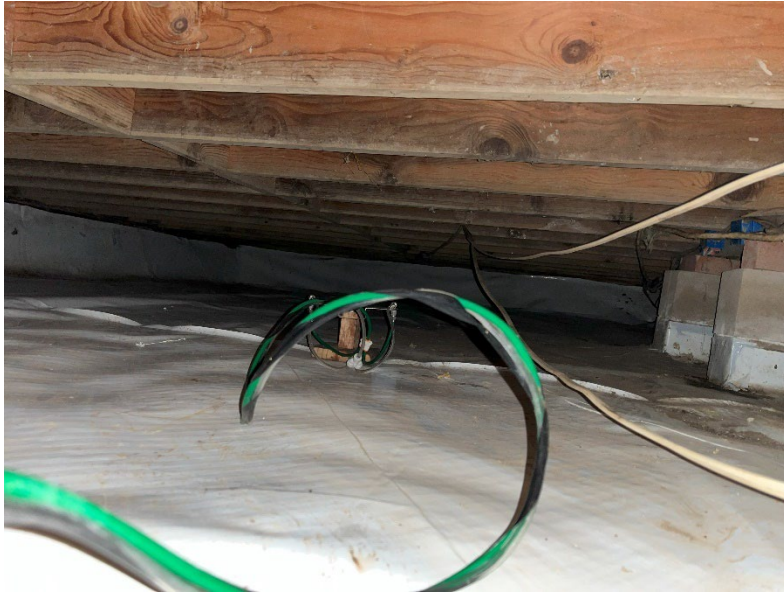
Figure 6. Photo of crawlspace sealed at Site 4.

Site 4 was a 2,491 ft² two-story home in California climate zone 3, with denim insulation in the attic and a small ~600 sq. ft. crawlspace below part of the home (Figure 6). The rest of the home's footprint was slab-on-grade with a garage and covered outdoor space. The insulation would have been labor intensive to remove, so the team elected to attempt crawlspace sealing only. Despite the limited available opportunity for sealing with the aerosols, this home was chosen to see if the technology could be effective on this limited scale.

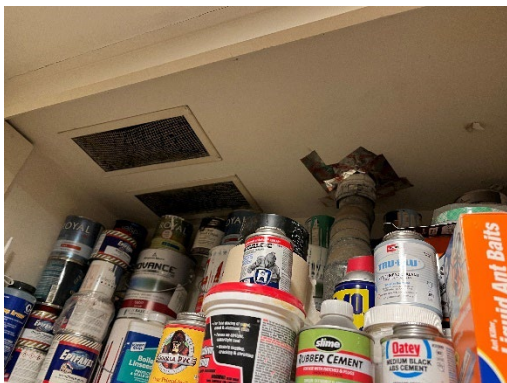
Figure 7. Makeup air grilles between the attic and water heater location in the home.

Blower door tests were conducted at Site 5 before the manual sealing of large openings was performed, showing a relatively high leakage of 12.7 ACH50. The leaks identified for manual sealing included a large gap around a light fixture and around an exhaust fan housing. The home was preparing for a full electrification upgrade, including replacing a natural gas furnace and hot water heater. These systems were both located in the home, but the new systems were getting installed outside of the conditioned space. Large openings for combustion makeup air were present between

the location of the gas appliances and the attic space. These openings were temporarily blocked for the aerosol sealing but scheduled to be permanently sealed as part of the retrofit work, so the results do not include the flow through those openings. Another blower door test was performed after the temporary seals were placed and was considered the baseline condition for the aerosol sealing effort, which showed 8.6 ACH50.

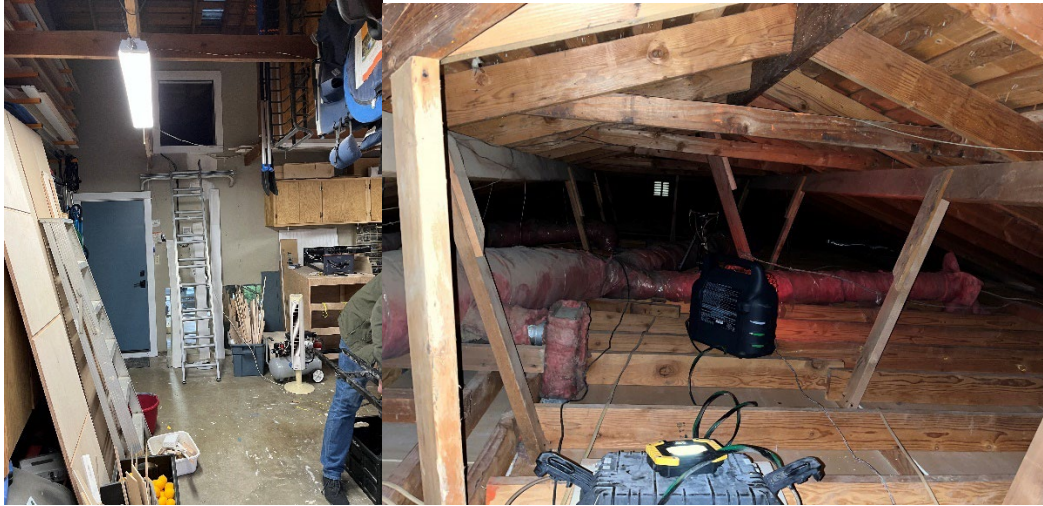
Figure 8. Attic access hole (left) and view from inside the attic (right).

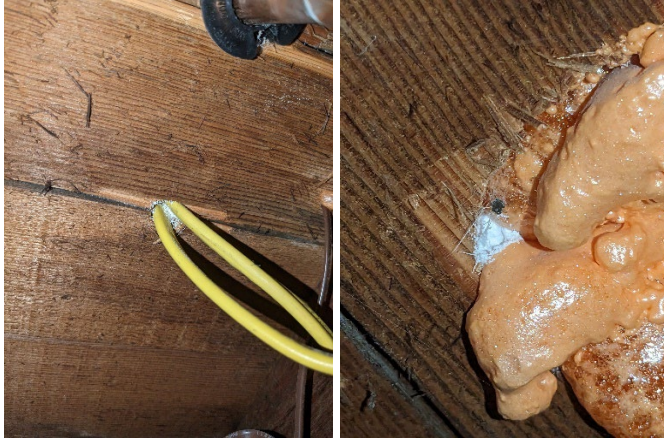
Figure 9. Seals formed at penetrations in the floorboard at Site 1

Aerosol fog inside the occupied space was noticeable, but very minor, especially compared with the traditional “inside-out” method. No deposition on the owner’s belongings was observed, but one window was opened a small amount during the sealing to help flush particulates out of the building. Opening the window did not affect the sealing process since overall leakage flow was low, and therefore pressure was able to be maintained. Figure 9 shows photos of some of the aerosol seals formed on the underside of the floorboards.

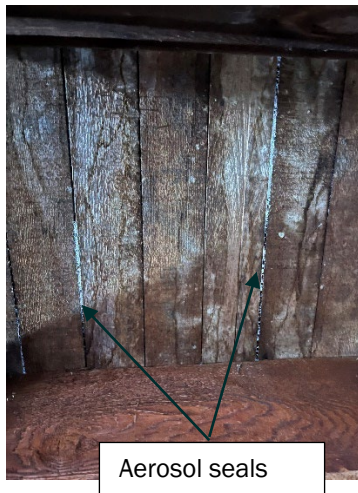
Figure 10. Example seals formed between floorboards at Site 2.

The baseline leakage for Site 2 was 3,738 CFM50, or about 18.6 ACH50 and included an attic and crawlspace. The sealing preparations included a temporary blocking of leaks, including large door undercuts leading to the attic and wiring penetrations near the entertainment center. This preparation resulted in a reduction of 665 CFM50, showing a significant potential for further sealing, with permanent sealing of those particular leakage sources. The sealing process took about 3.25 hours, including setup and teardown. Partway through sealing, a large hole under a sink was identified and manually sealed, which represented 250 CFM50 of total leakage. There was also a decision to move two crawlspace nozzles to the attic during the sealing process to improve sealing of the top envelope. In the future, more injection units would be desired to avoid the additional time required to move equipment. Overall, the process was quite successful, considering the initial state of the envelope. The leakage sealed, including the manual sealing under the sink, was 1,639 CFM50 (8.1 ACH50), or 44 percent of the total, for an end result of 10.4 ACH50. Figure 10 shows examples of aerosol seals formed between floorboards at Site 2.

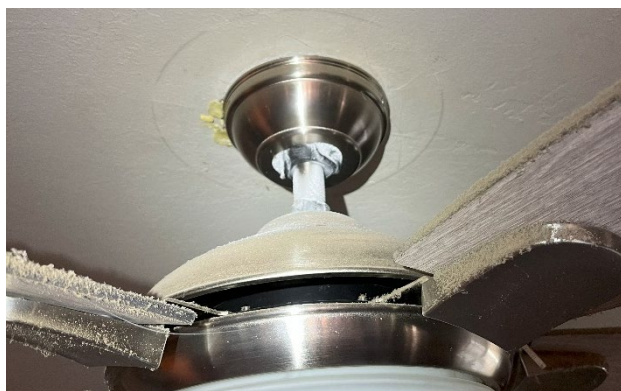
Figure 11. Buildup of sealant on ceiling fan.

Site 3 presented some challenges due to the limited access in the crawlspace. That issue, along with equipment limitations, prevented proper development of a high-humidity aerosol fog in both the attic and crawlspace, resulting in humidity levels that were lower than optimal. Even with these challenges, the aerosol sealing process was very effective. The initial house leakage was 1,628 CFM50 or 10.2 ACH50, and sealing was able to reduce that by 596 CFM50 (3.7 ACH50) or 37% for an end result of 5.7 ACH50. The lack of adequate fogging due to limitations with the prototype equipment caused sealing rates to be slow. Ultimately, the research team ran out of time before fully completing the sealing. This impacted the total amount of sealing accomplished, and it is expected that additional nozzles would have resulted in more leakage sealed and faster sealing rates. After sealing, some deposition was noted on the ball-joint in a ceiling fan (Figure 11). This deposition was easily cleaned but was noted as an area potentially requiring surface protection in future installations.

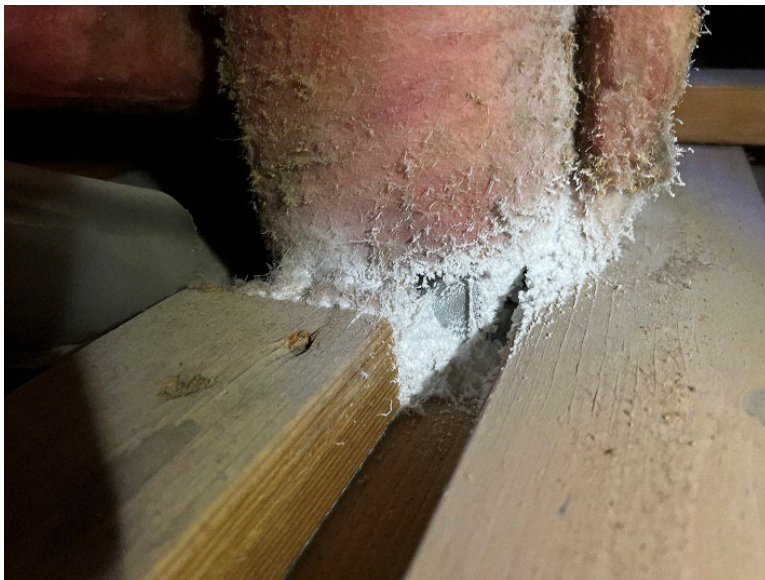
Figure 12. Sealant deposition on ductwork at register boot connection.

Another advantage of the attic and crawlspace sealing approach is that any ductwork in those locations in the building could potentially be sealed in the process. Site 5 had sheet metal ductwork present in the attic, and a duct leakage test before and after sealing was performed to determine the impact on duct leaks. The metal ducts were wrapped in fiberglass insulation which was not removed as part of the attic insulation removal process. The insulation on the ductwork impacted the duct sealing effectiveness, but the exposed parts near register boot connections were available to be sealed (Figure 12). Overall, the process sealed 133 CFM25 or 34% of the total duct leakage. There were signs of leakage beneath the insulation as evident by sealant buildup on the insulation and it is expected that removing the insulation prior to sealing would have resulted in better performance.

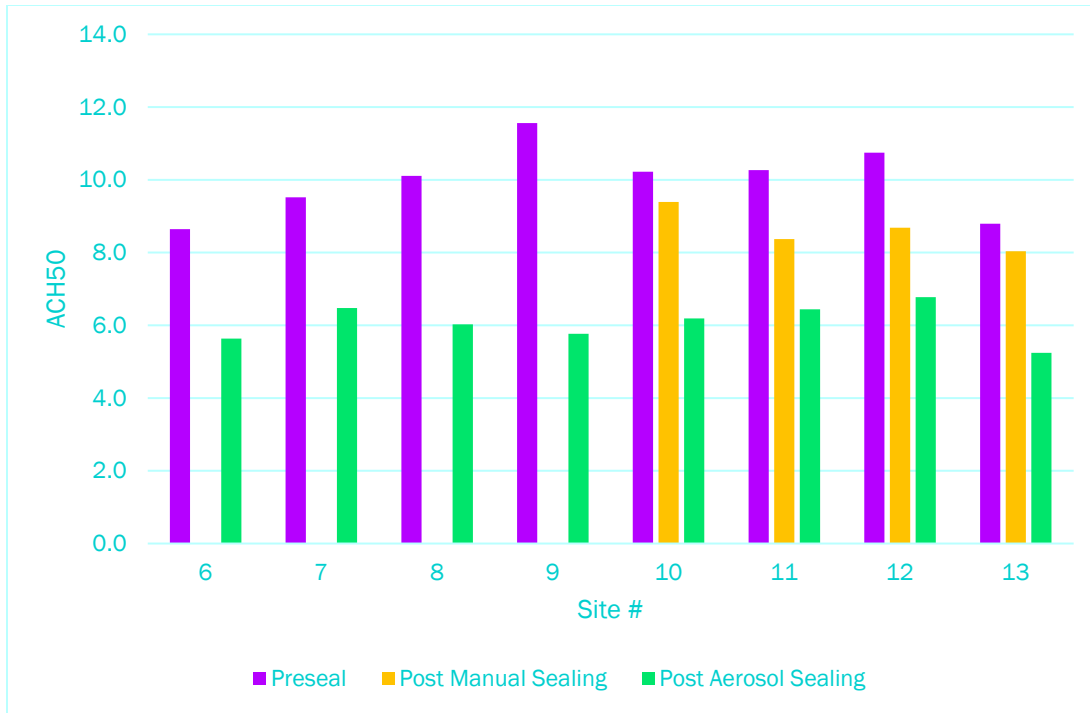
Figure 13. ACH50 for multifamily sites before sealing, after manual sealing for sites 10-13, and after aerosol sealing.

Table 4 presents the air leakage results for sites 6 to 13 before and after the different sealing approaches, which is also illustrated in the plot in Figure 13. The as-found leakage rate for each apartment was generally consistent, except for units that had linen closets with unfinished walls, and excessively leaky range hoods. Manual sealing using canned foam resulted in a leakage reduction of 8- to 19 percent, which is significantly less than aerosols alone which sealed 32 to 50 percent. However, the canned foam did fill larger leaks which would have been more time consuming with the aerosol method. The combination of aerosols and canned foam did not result in a significantly better final result, but it did reduce the time for aerosol spraying. For sites 6 to 9 the average aerosol sealing time was 88 minutes, while sites 10 to 13 took an average of 52 minutes.

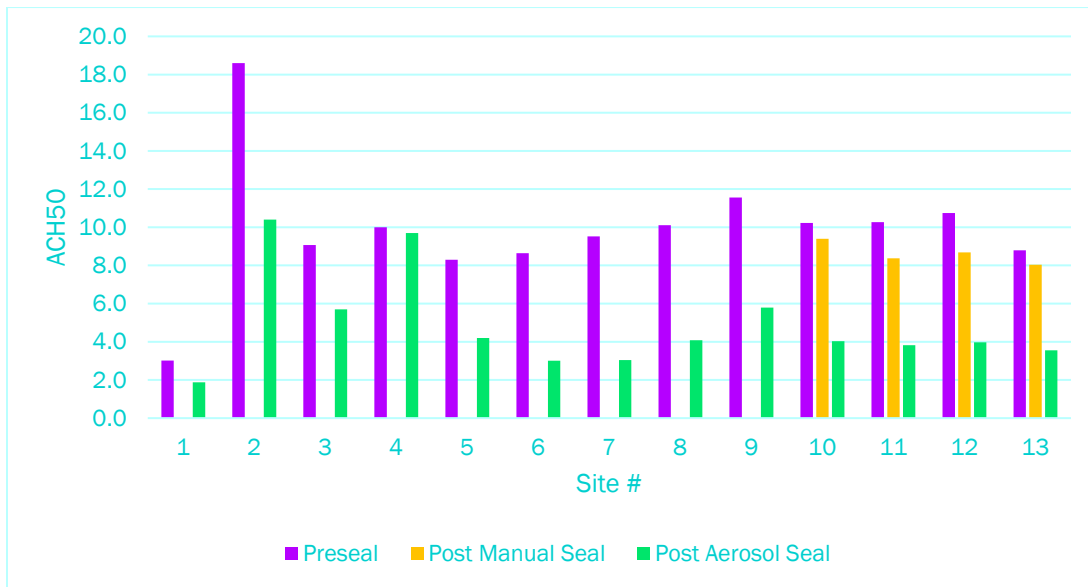
Figure 15. Summary of results from aerosol attic/crawlspace sealing.

single-family and multifamily residences. The results show that the aerosol sealing methods applied can significantly improve retrofit air sealing measures for homes. The air leakage reductions achieved with the aerosol approach were more than 2.5-times more effective than manual sealing with canned foam with three sites achieving reductions of over 1,000 CFM50. Figure 15 shows the summary of test results for all sites, including the testing conducted on manual sealing with canned foam. The average leakage reduction across all test sites was 687 CFM50 or 37 percent of the total leakage of the homes.
